Technical Service Information

MERCEDES 722.3 / .4 ERRATIC DOWNSHIFTS

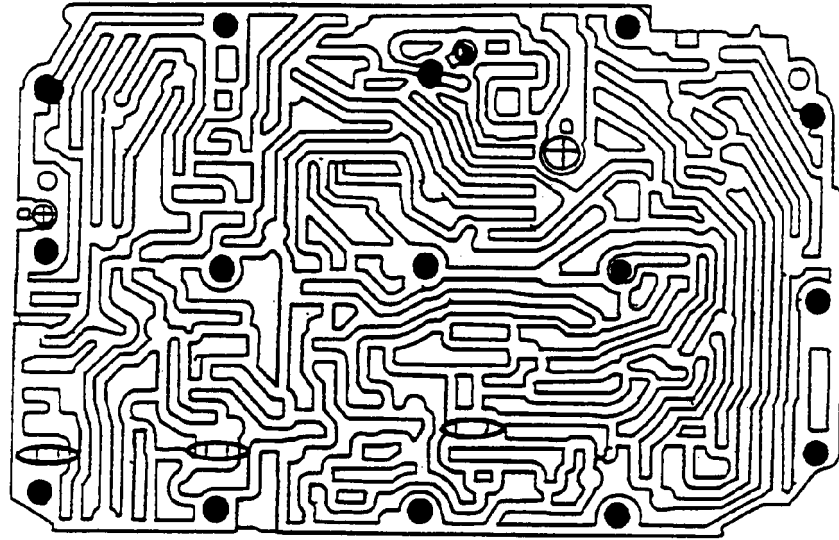
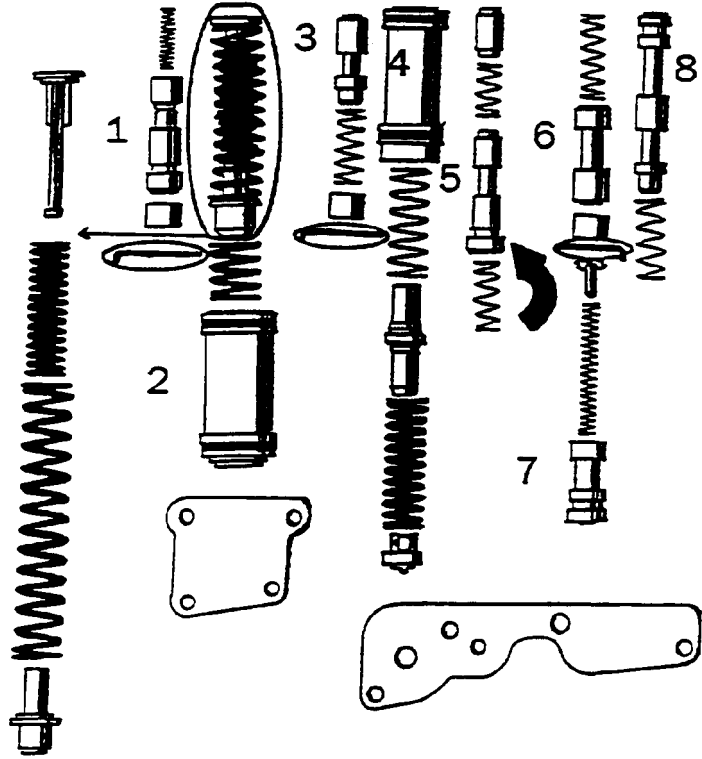
COMPLAINT: Erratic 4-3 3-2 downshift, other times it does not. Sometimes it does occur and at all.

CAUSE: Throttle linkage and/or control pressure detent/Bowden cable is not adjusted properly, or the reaction valve in the valve body is binding. Or the shut off valve is binding. Figure 1 and Figure 2 show the location of these valves.

CORRECTION: Drive the vehicle with the detent cable disconnected (control pressure Bowden cable). If manual downshift will take place then the problem is not the transmission nor the valve body, but that the detent/Bowden cable is out of adjustment. Make necessary adjustment to the cable. If the downshift still will not occur, then the problem is either the RV5 shut off valve shown in Figure 1 is binding or the brake shut off valve in Figure 2 is binding.

CAUTION: It is important that the valve body bolts be properly torqued. On this model unit the bolts holding the valve body together should be torqued to 65 in. lbs. and the bolts that secure the valve body to the case should also be torqued to the 65 in. lbs. setting.
