DTC P0741 – Torque Converter Clutch Does Not Lock Up – Missing O-ring

MODEL 2000 MY-ON
S-TYPE

VIN L00600-L12500

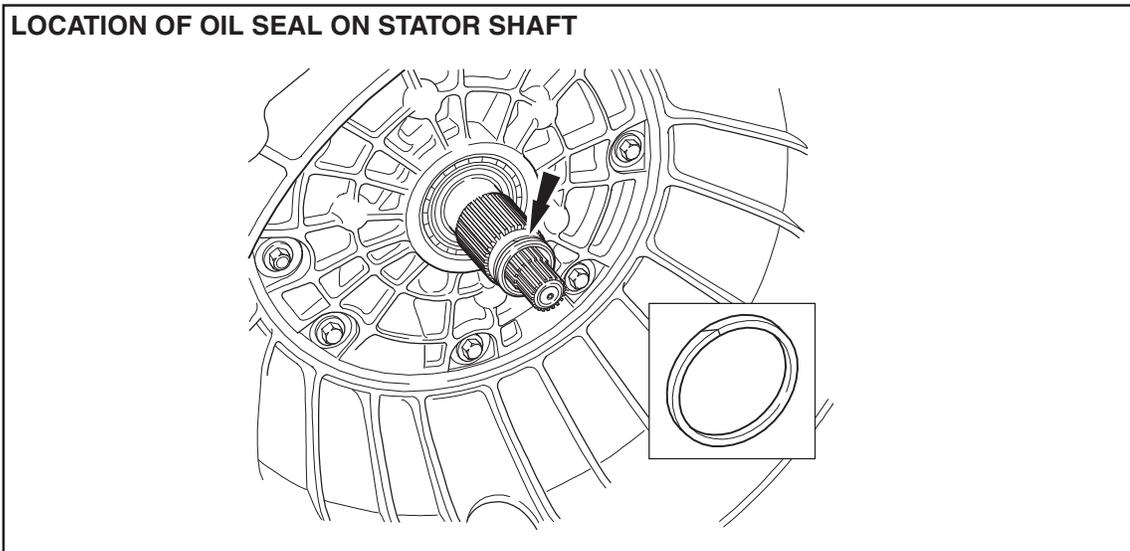
ILLUSTRATION 1

Some 2000 MY S-TYPE vehicles may experience a MIL illumination with diagnostic trouble code (DTC) P0741 stored in the PCM. This condition is most likely to result from the omission of an oil seal on the transmission stator shaft during assembly of the unit.

The function of the oil seal is to complete a hydraulic circuit intended to allow transmission fluid under pressure to actuate the lock-up clutch under certain conditions. Omission of the seal allows fluid to by-pass the intended circuit. This fluid then recirculates in the torque converter without actuating the lock-up clutch. The condition will be confirmed by the presence of DTC P0741.

LOCATION OF OIL SEAL ON STATOR SHAFT

3. Inspect the stator shaft and determine if the seal is damaged or if no seal is present at the location shown in illustration 1.

The concern may be overcome by installing a seal at the correct location.

4. If no seal is present, install a seal into the groove as illustrated and continue with step 5. If a seal is present and is undamaged contact the Technical Hotline at 1-800-JAG-DLRS for repair guidance.

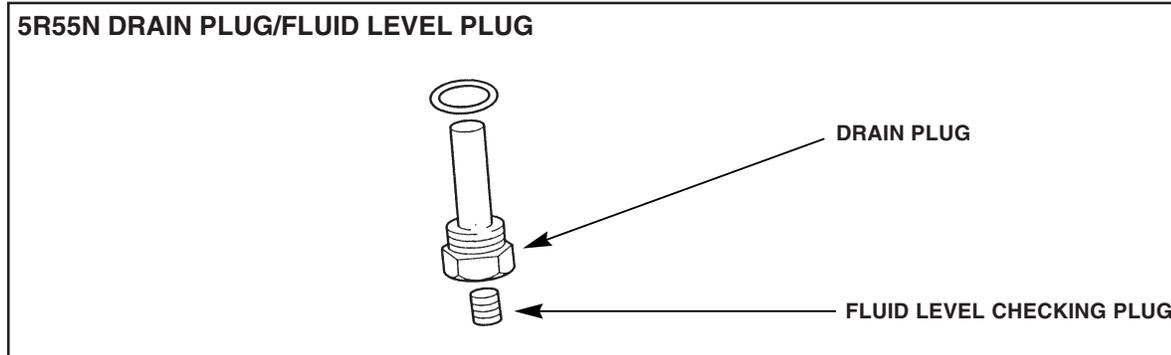
ILLUSTRATION 1

16. Engage Park and keep engine running. Immediately raise the lift (engine still running) and perform fluid level check.
17. **Remove the hexagonal fill plug on the extension housing** and remove the fluid level plug. The level plug is located within the hexagonal drain plug on the underside of the transmission oil pan (Illustration 1).

18. Hold the hexagon of the oil drain plug to prevent it turning, using a 7/8" or 22mm ring or open ended wrench, while removing the oil level plug using a 3/16" AF Hexagon (Allen) drive bit.
19. The transmission may be either under-filled or over-filled from the nominal condition.

Underfilled: If a few drips are all that comes out then the transmission is **underfilled** - add oil via the fluid fill plug on the extension housing. Use proper automatic transmission oil as listed above, adding no more than 250 ml at a time until the fluid drains out of the fluid level plug in a continuous stream - **replace the fluid level plug as soon as the stream starts to break up into drips.**

Overfilled/Slightly overfilled: Fluid should drain out in a continuous red stream - **replace fluid level plug as soon as stream starts to break up into drips.** If more than 250 ml drains off then go to the extremely overfilled procedure.
