# Technical Service Information

## ZF-4HP-22/24

### REPEATED LEAK FROM BELL HOUSING AREA

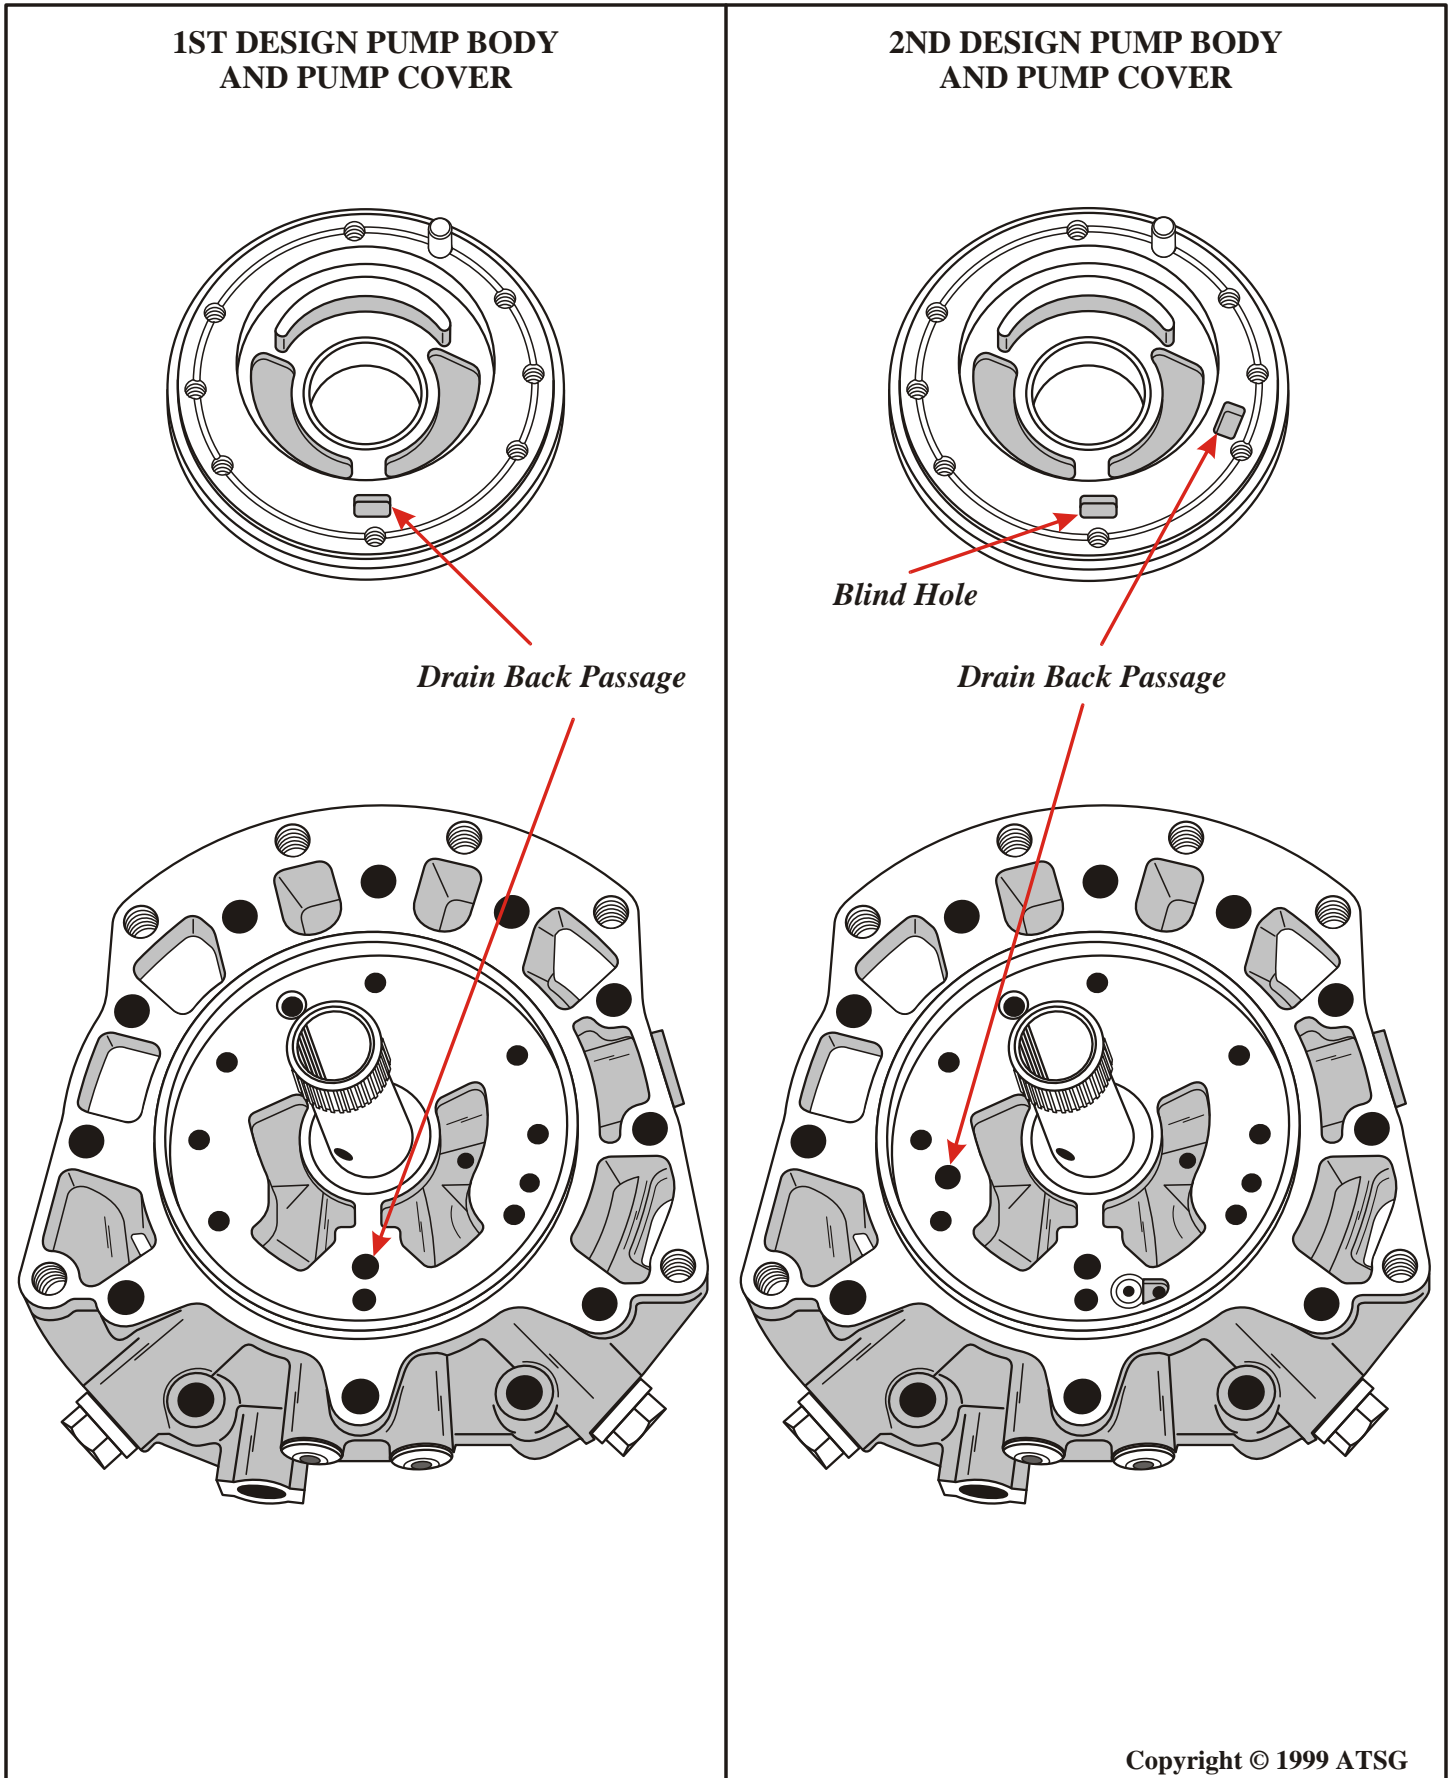
Figure 1

- COMPLAINT:** Repeated leakage of transmission fluid, coming from the bell housing area on any vehicle equipped with the ZF-4HP-22 or 4HP-24 transmission. This usually occurs after rebuild coupled with pump parts replacement that was necessary.

- CAUSE:** Beginning in the 1989 model year, ZF implemented a running change to the pump body and pump cover on both the 4HP-22 and the 4HP-24 transmissions. This change was made to increase the durability of the converter bushing with increased lubrication to this area. This change however, created the possibility of mis-matching parts that are not compatible. The 1st design pump body and cover has the drain back hole located at the 6 O'clock position and the drain back passage was moved to the 3 O'clock position in the 2nd design pump body and cover, as shown in Figure 1. Installing 2nd design pump body with 1st design pump cover will completely block the drain back passage and the repeated leakage will occur. Installing the 1st design pump body with 2nd design pump cover will function, but you will now be faced with the possibility of premature converter bushing failure.

- CORRECTION:** To eliminate both conditions, always install the 2nd design pump body, matched with the 2nd design pump cover, as shown in Figure 1.
