AUDI 4000/5000 SERIES LATE AND/OR NO UPSHIFTS "COLD ONLY"

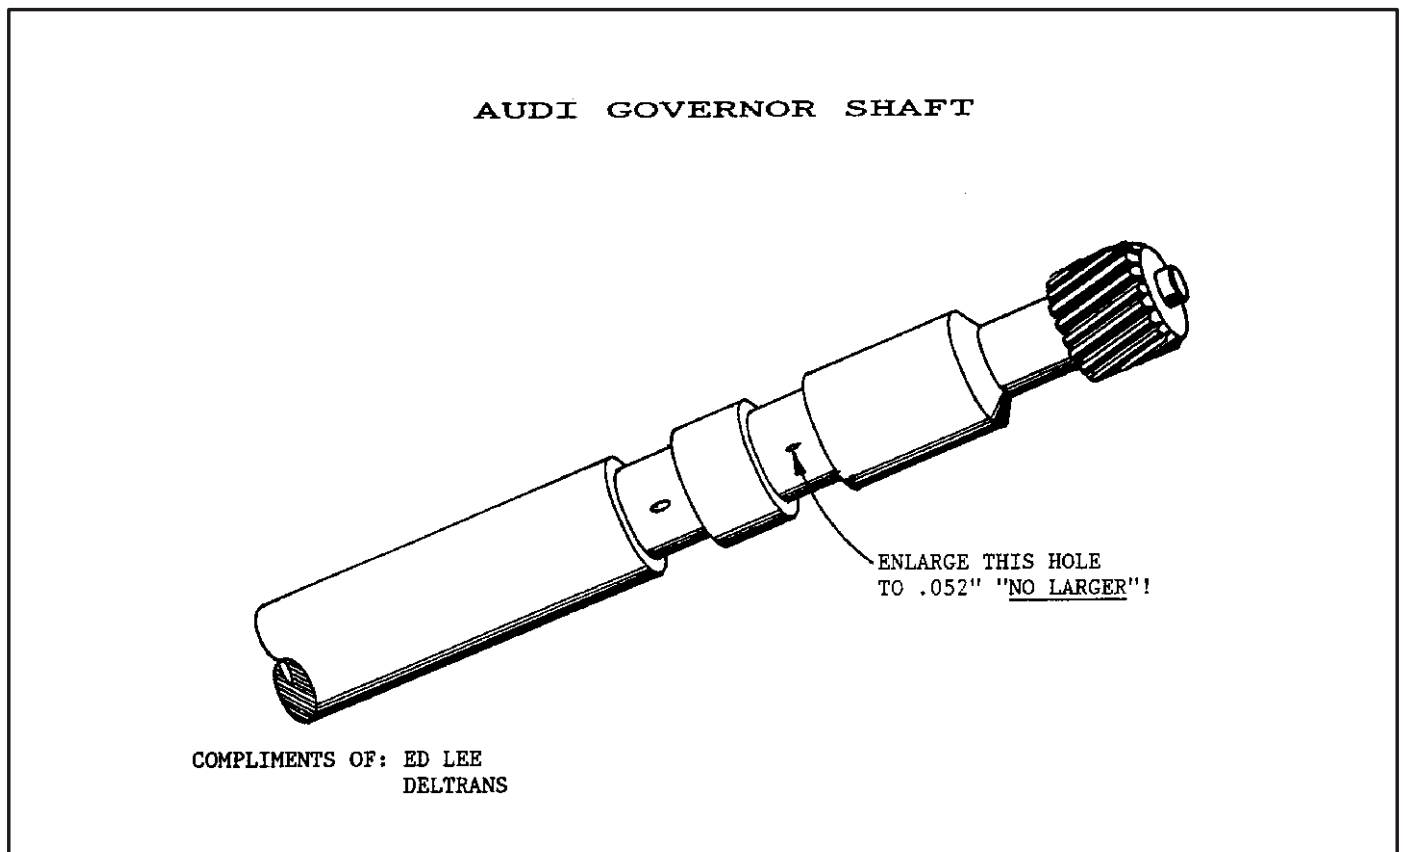
Figure 1

- COMPLAINT:** Some Audi 4000-5000 series vehicles may experience late upshifts and/or no upshifts "COLD ONLY". After the transmission fluid is warm, the transmission shifts properly for the rest of the day.
- CAUSE:** If all other possibilities have been eliminated, the cause may be not enough drive oil being fed to the governor. The volume of COLD oil that can get through the governor shaft orifice may not be sufficient to return governor pressure to the shift valves in the valve body.
- CORRECTION:** Enlarge the small governor shaft feed hole from the present size to .052", "NO LARGER". The governor feed hole is the one that is closest to the governor gear, as shown in Figure 1. The difference in size is very minimal and not much material will be removed from the governor shaft. Be certain to clean all material from governor and the governor shaft after this procedure.
