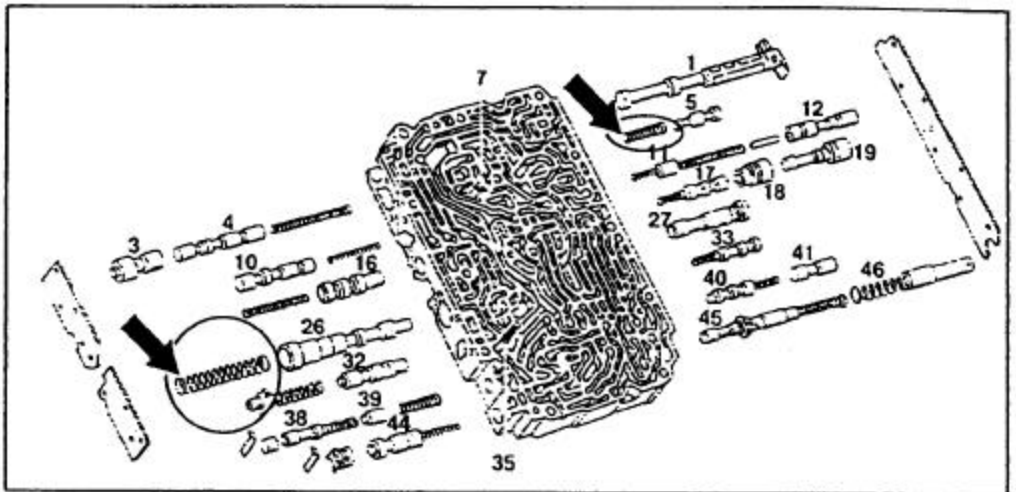
Figure 1

Insufficient working pressure due to incorrect adjustment of injection pump vacuum control valve (VCV) and hydraulic influences of the valve body.

2. If transmission was produced prior to Production Phase-in listed below, remove spring from Control valve converter adaptation (5) in valve body (oval, Figure 1).

3. Install modified spring in Control valve working pressure (26) in valve body (circle, Figure 1). Refer to Parts Information listed below.
